HYDROGEN INFLUENCE ON EXPLOSIVE WELDED CORROSION RESISTANT CLAD MATERIALS FOR GEOTHERMAL PLANTS

M. Gloc¹, Ł. Ciupiński¹, G. Kwiatkowski²
michalgloc@wp.pl

Project „Novel explosive welded corrosion resistant clad materials for geothermal plants”

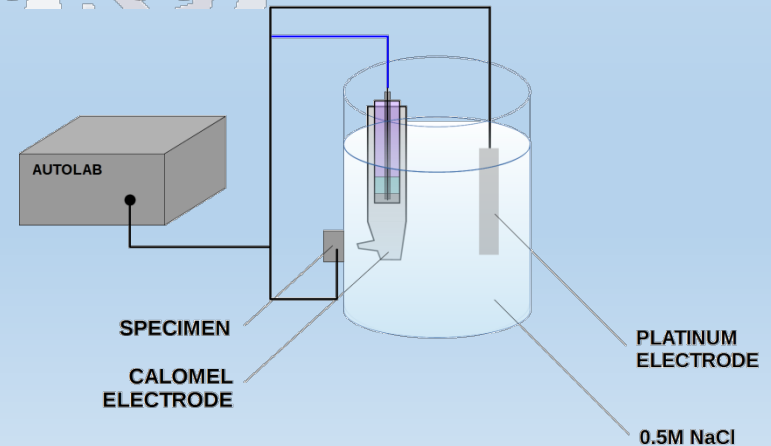
- Electrochemical impedance spectroscopy (EIS)
- Anodic polarization curves
- Linear polarization resistance
- Hydrogen cathodic charging
- Measurements of deformations in samples during hydrogen charging

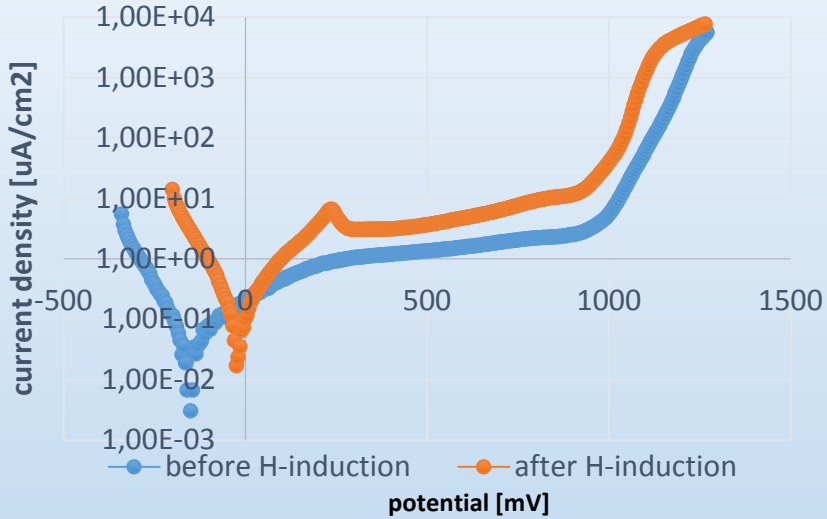
Sample 2.1

Before H-charged:

$i_{cor} = 0,0532 \mu A$
 $E_{cor} = -179 mV$
 $E_{br} = 964 mV$
 corrosionrate:
 $2,497 \cdot 10^{-4} \frac{mm}{year}$

After H-charged:

$i_{cor} = 0,8585 \mu A$
 $E_{cor} = -28 mV$
 $E_{br} = 953 mV$
 corrosionrate:
 $1,994 \cdot 10^{-3} \frac{mm}{year}$

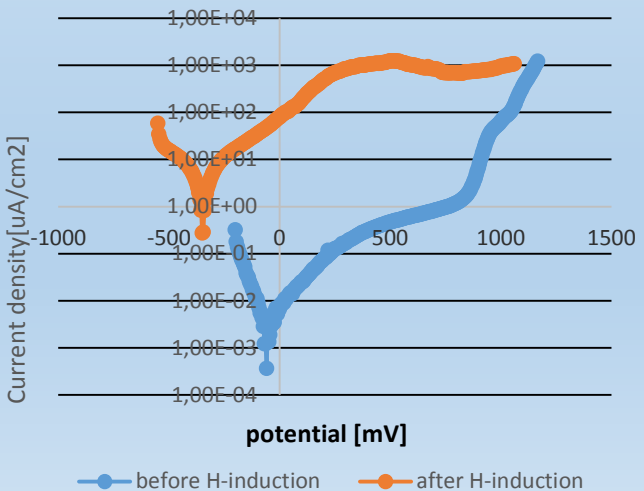
Sample 2.1 (annealed)

Before H-charged:

$i_{cor} = 0,00172 \mu A$
 $E_{cor} = -66 mV$
 $E_{br} = 817 mV$
 corrosionrate:
 $3,994 \cdot 10^{-5} \frac{mm}{year}$

After H-charged:

$i_{cor} = 2,304 \mu A$
 $E_{cor} = -352 mV$
 corrosionrate:
 $352 \cdot 10^{-2} \frac{mm}{year}$

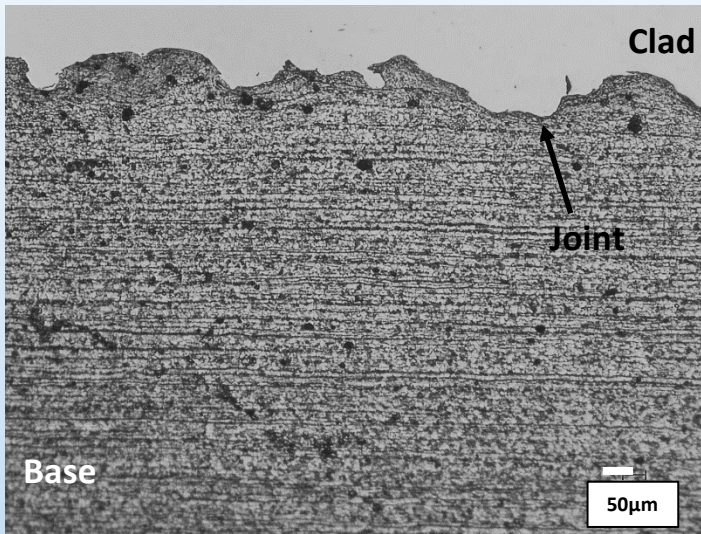
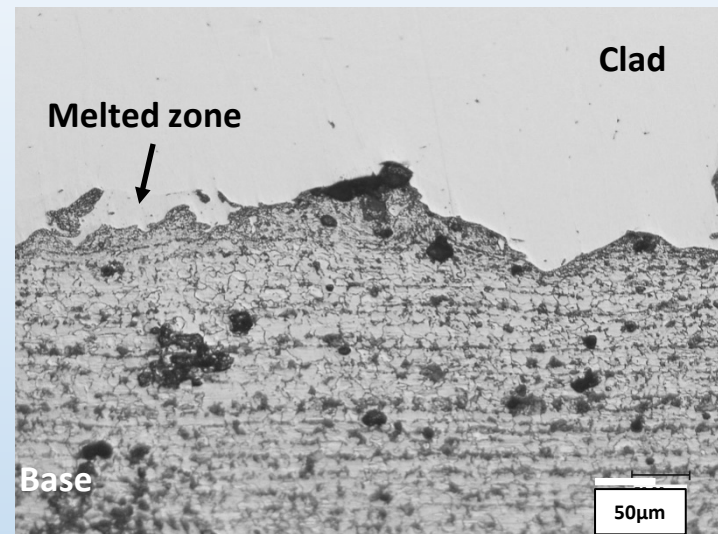
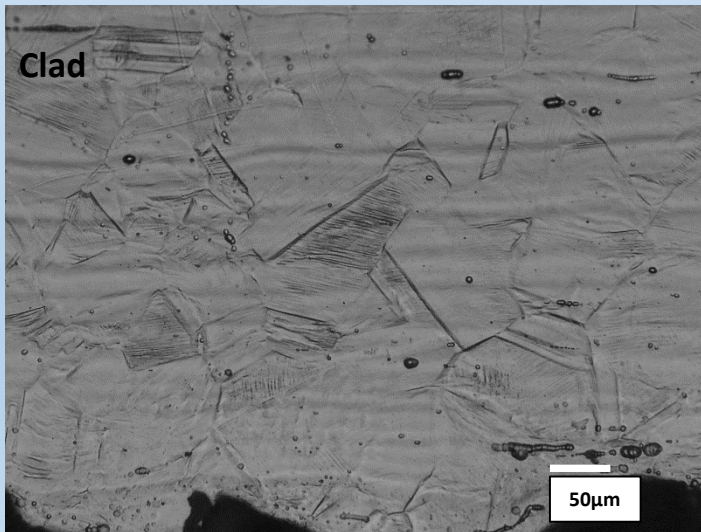
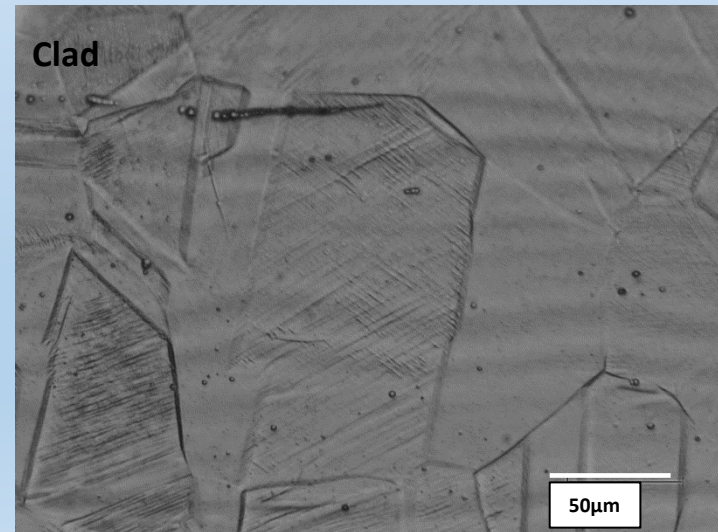
Sample 1.1 Base material: P355NH; Plate material: Inconel C-276. LM

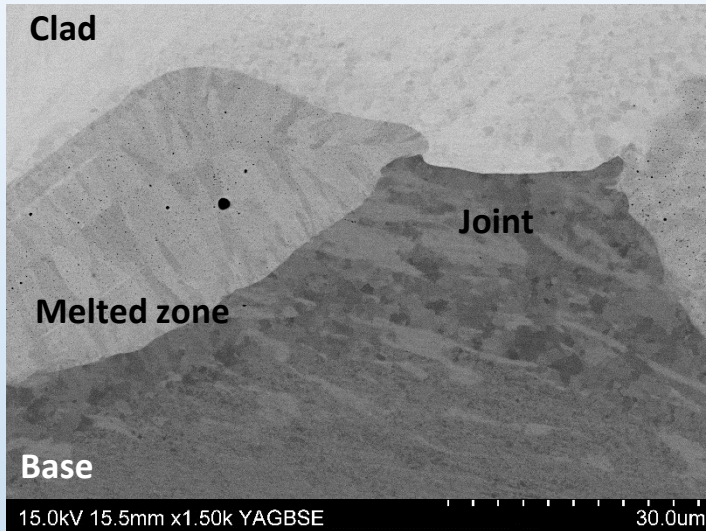
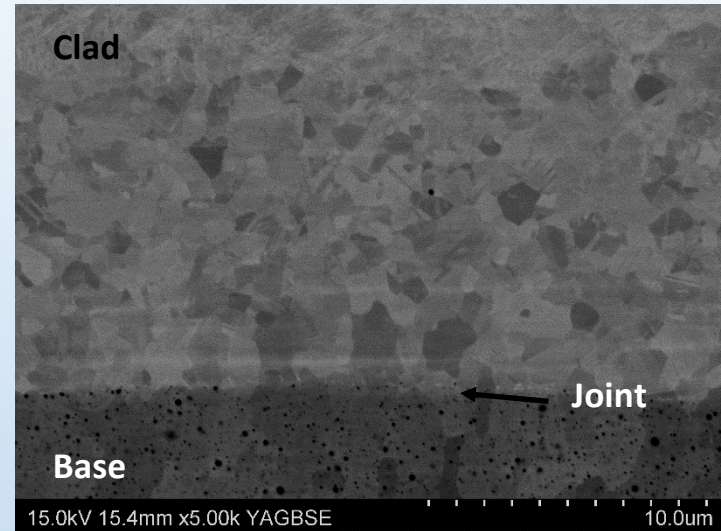
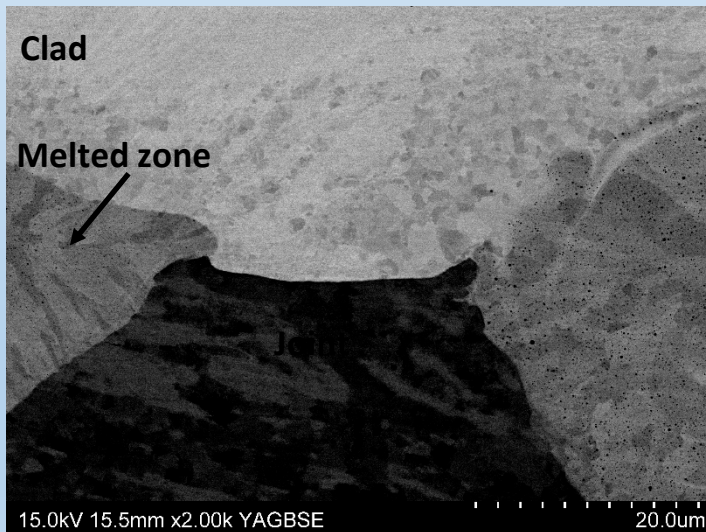
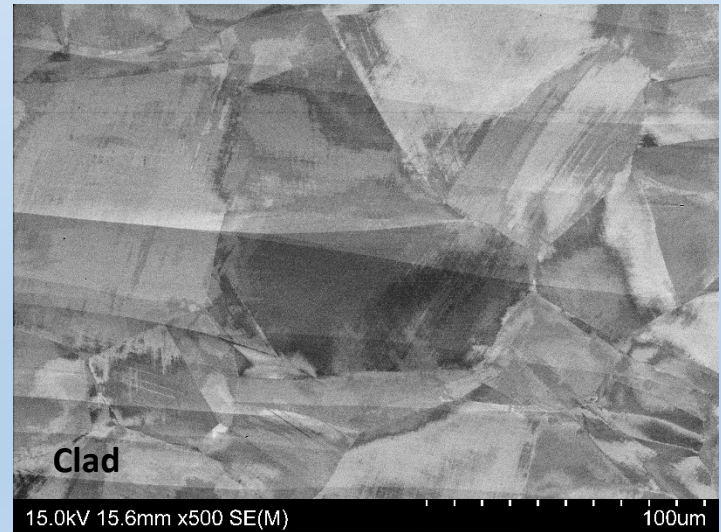
Sample 1.1 Base material: **P355NH**; Plate material: **Inconel C-276**. SEM

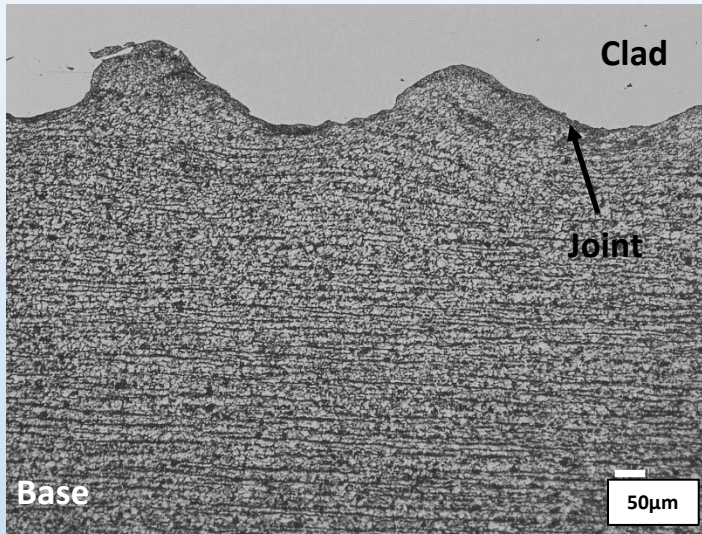
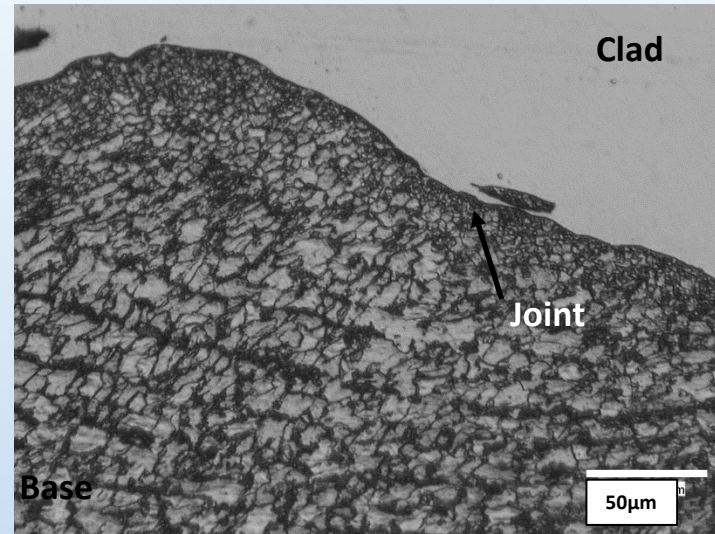
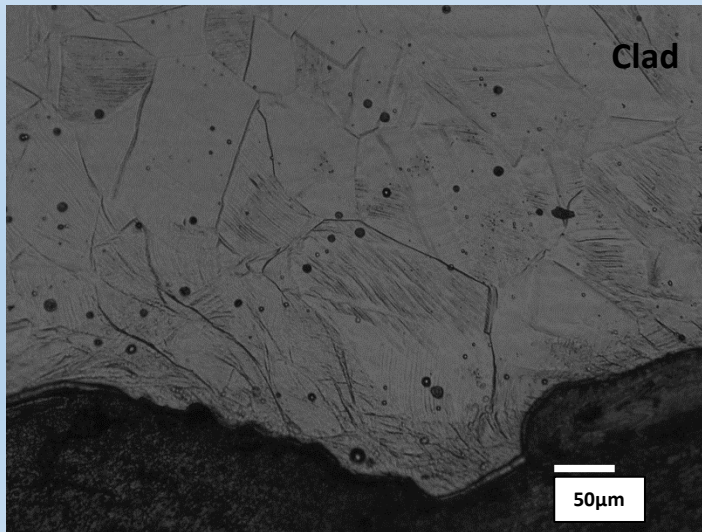
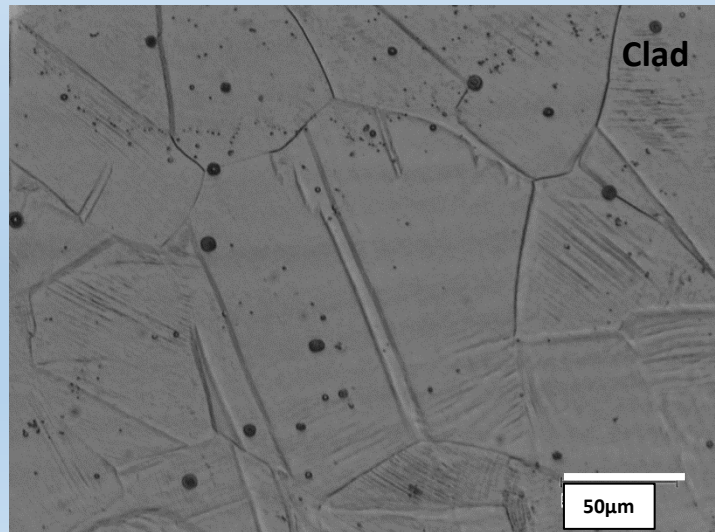
Sample 1.2 Base material: **P355NH**; Plate material: **C-276, Inconel** .LM

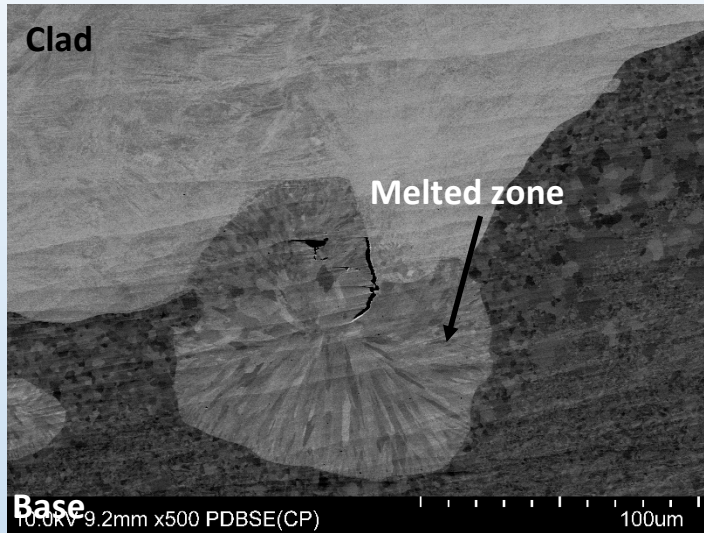
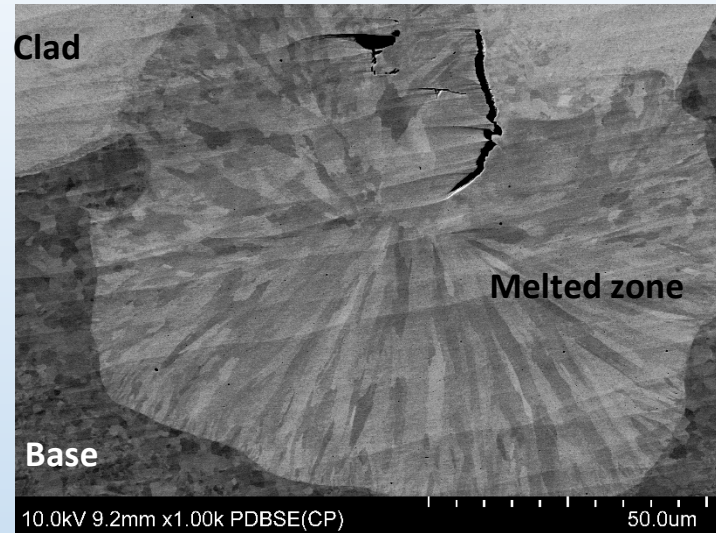
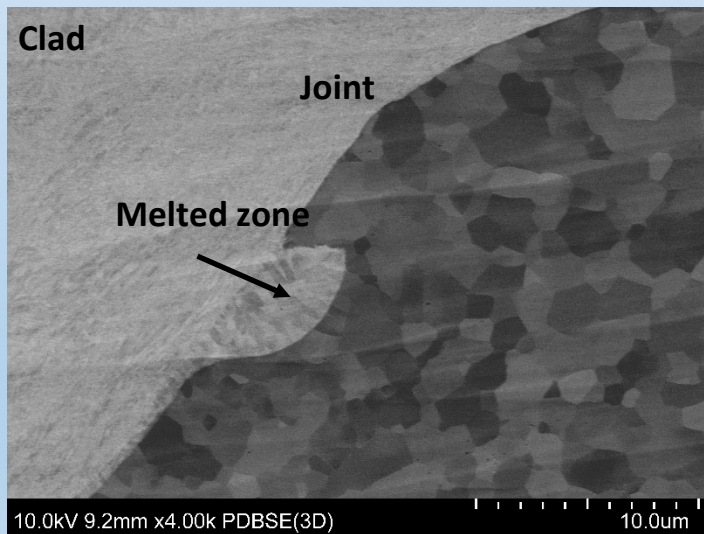
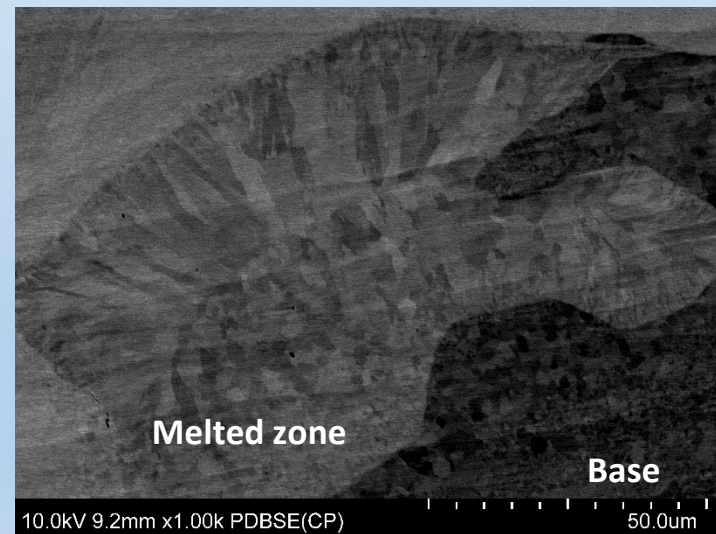
Sample 1.2 Base material: P355NH; Plate material: Inconel C-276. Heat treatment. SEM

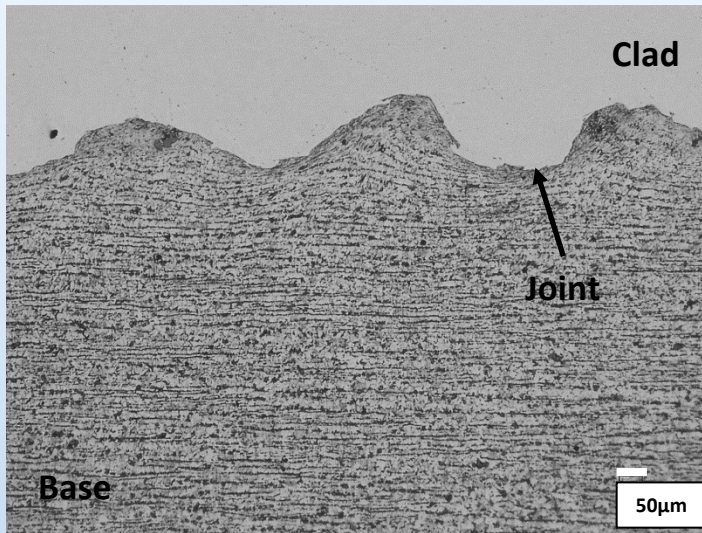
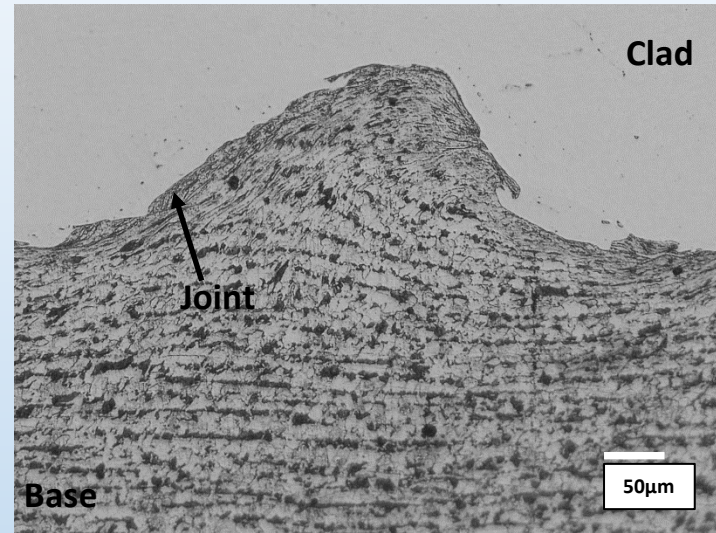
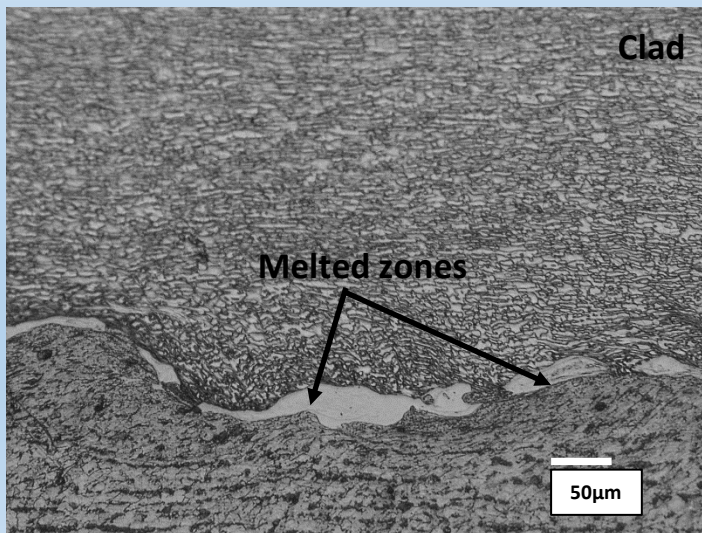
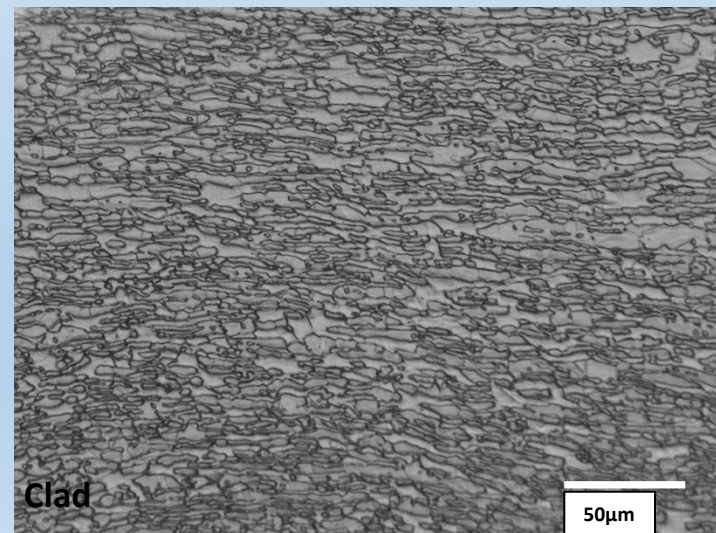
Sample 2.1, Base material: **P355NH**; Plate material: **SAF 2507**, austenitic-ferritic stainless steel. **LM**

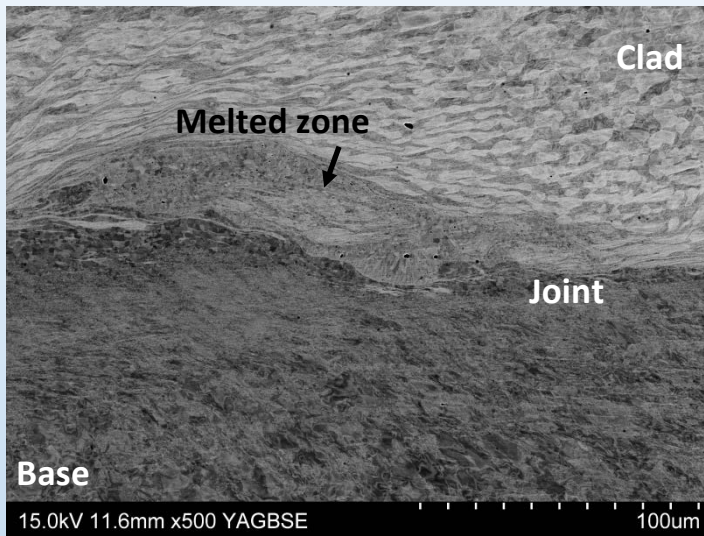
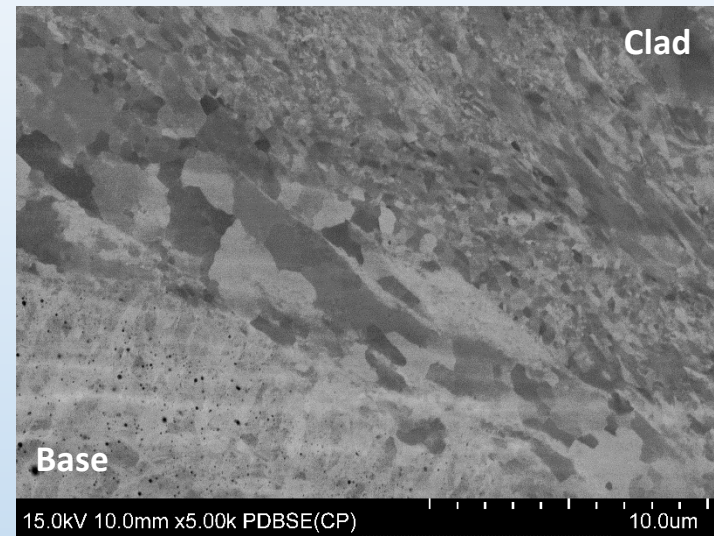
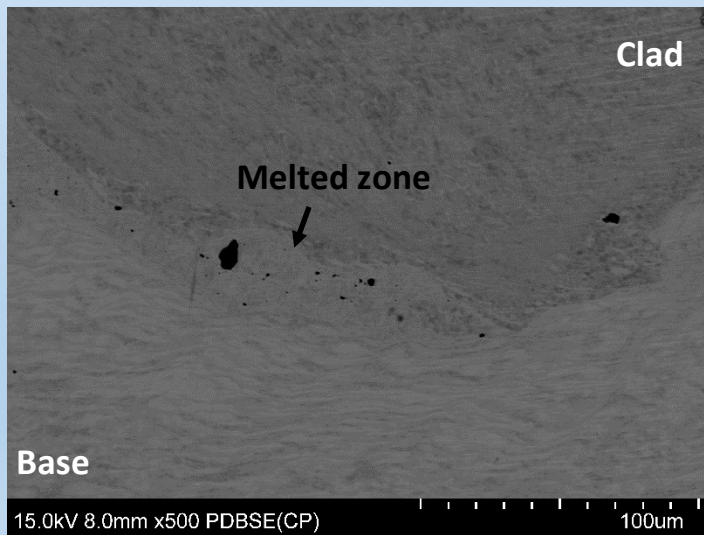
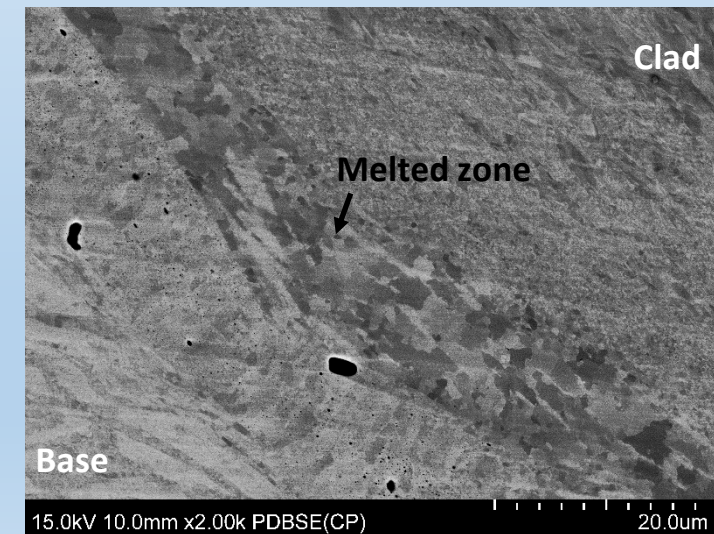
Sample 2.1, Base material: **P355NH**; Plate material: **SAF 2507**, austenitic-ferritic stainless steel. SEM

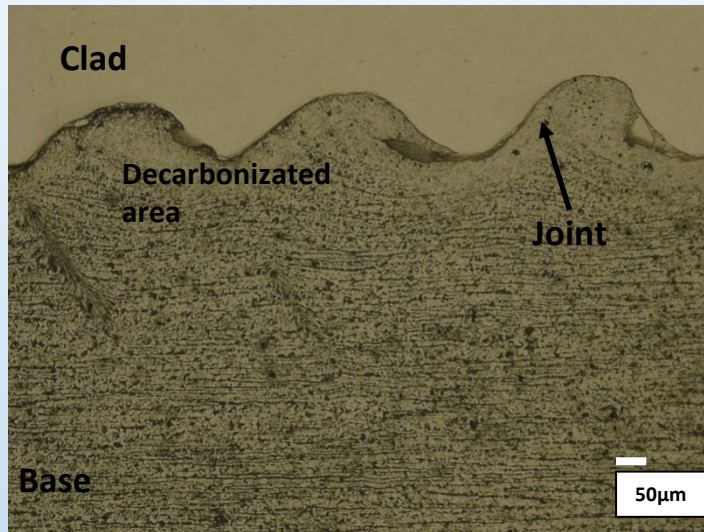
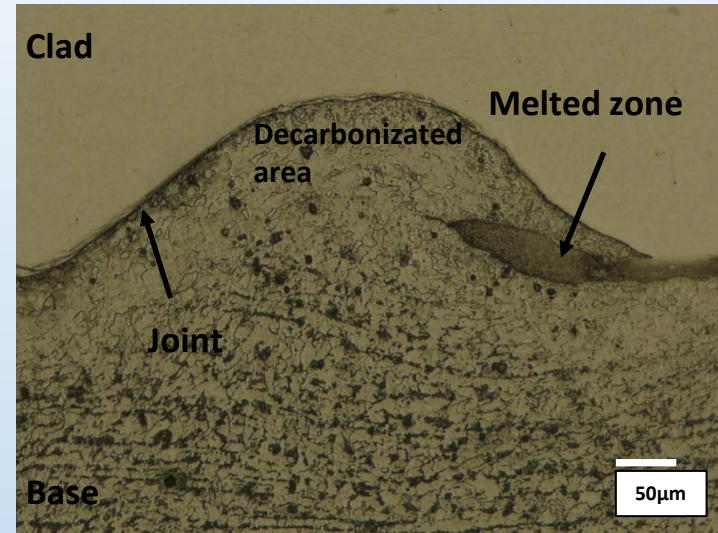
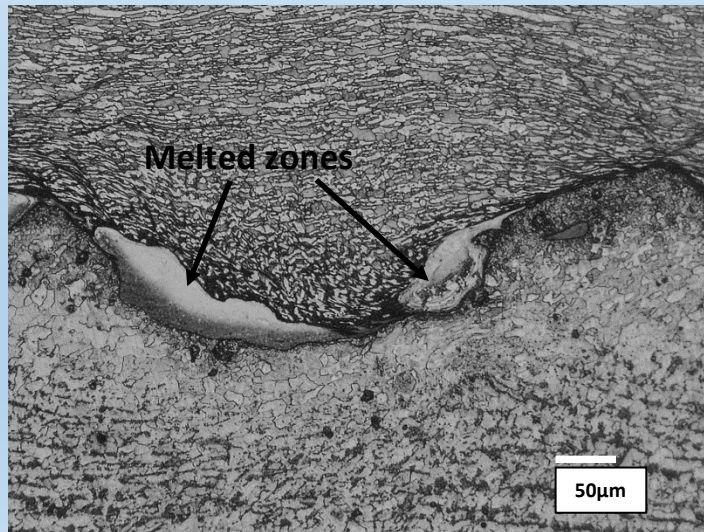
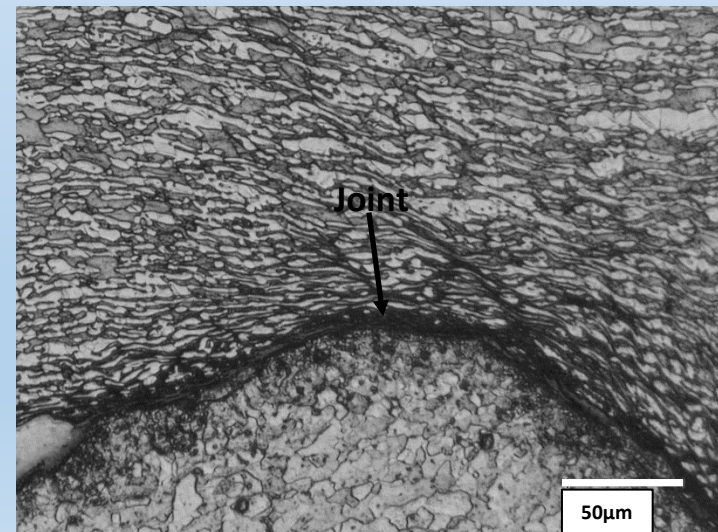
Sample 2.2, Base material: P355NH; Plate material: austenitic-ferritic stainless steel SAF 2507. LM

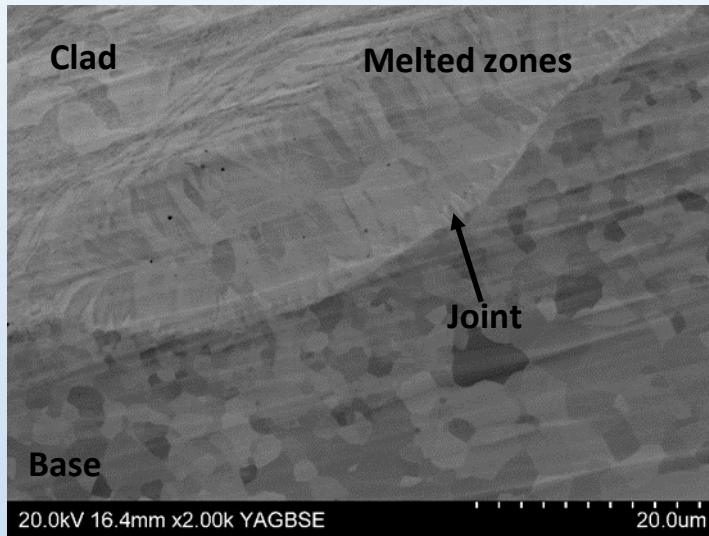
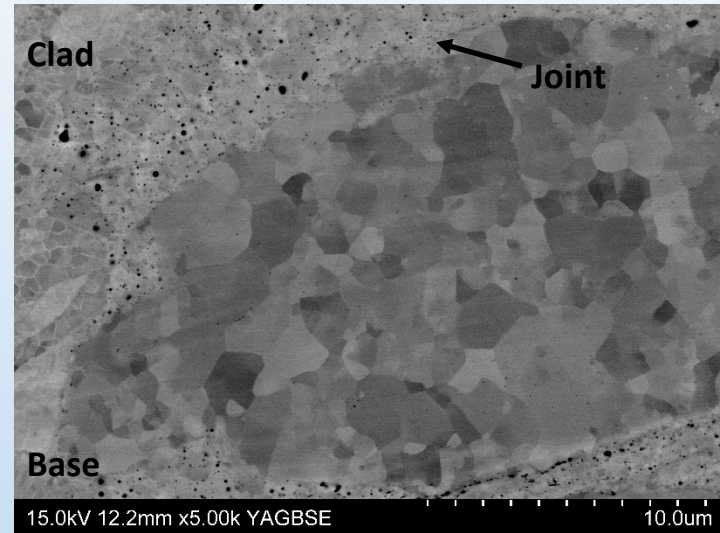
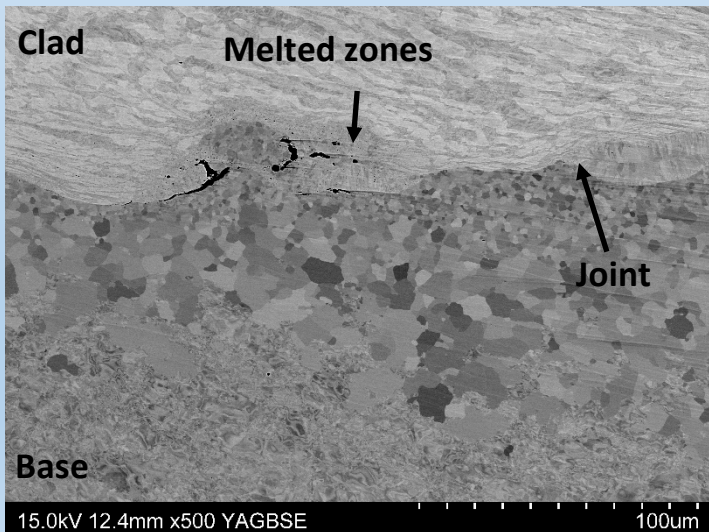
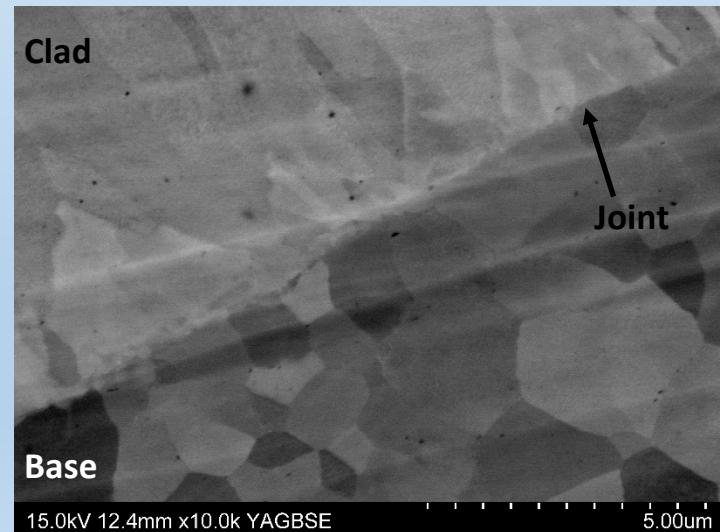
Sample 2.2, Base material: P355NH; Plate material: austenitic-ferritic stainless steel SAF 2507.SEM

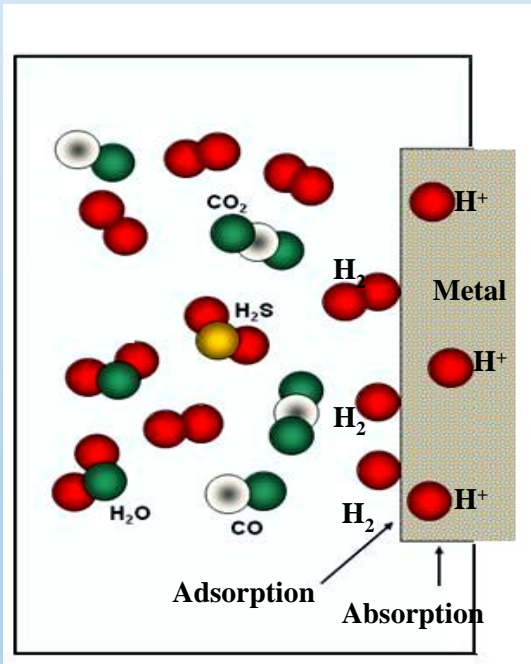
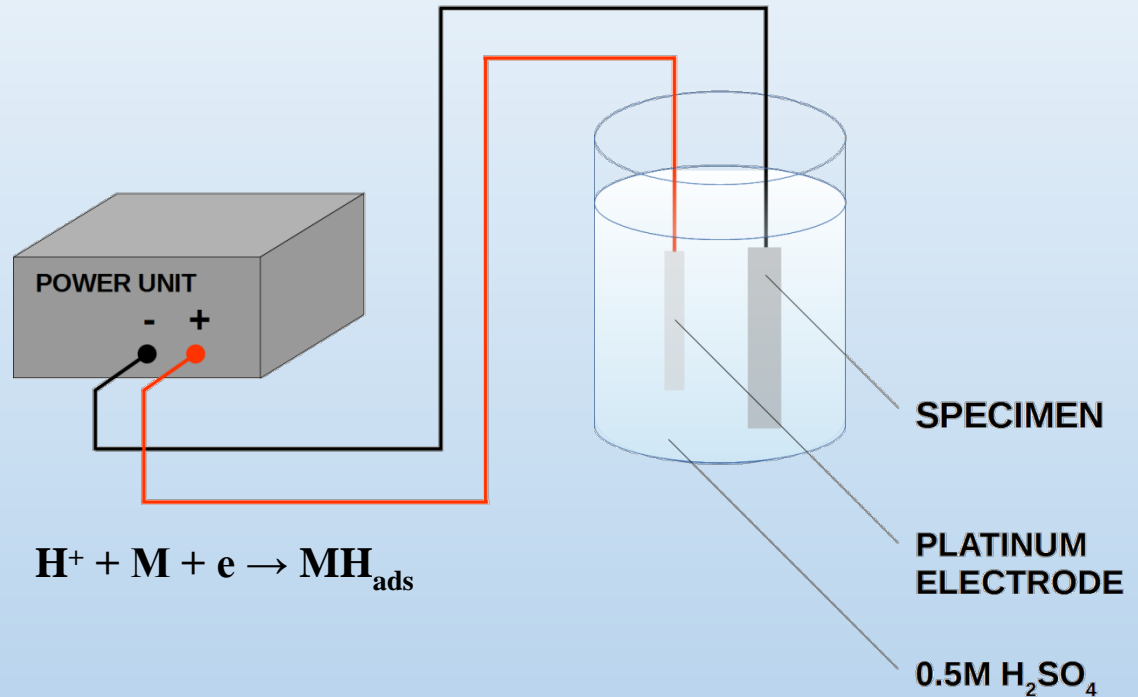
Hydrogen charging parameters:

- 0.5M H₂SO₄ solution, with addition hydrogen entry promoter
- ambient temperature
- current density: 50mA/cm²
- time: 2 - 18 hours

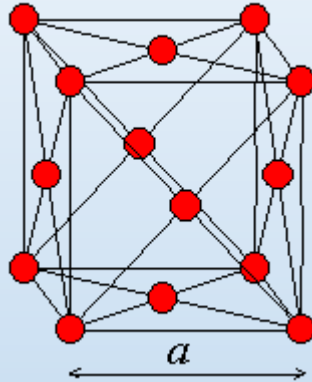
FCC

austenite

BCC

ferrite

hydrogen diffusion coefficient

hydrogen solutibility

**LOCAL
SUPERSATURATION
OF HYDROGEN**

DISBONDING

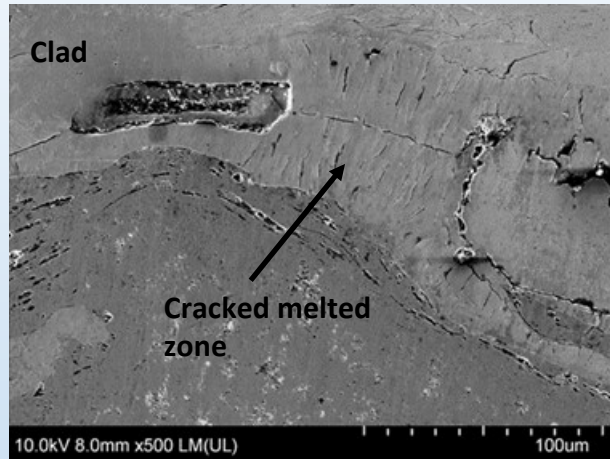
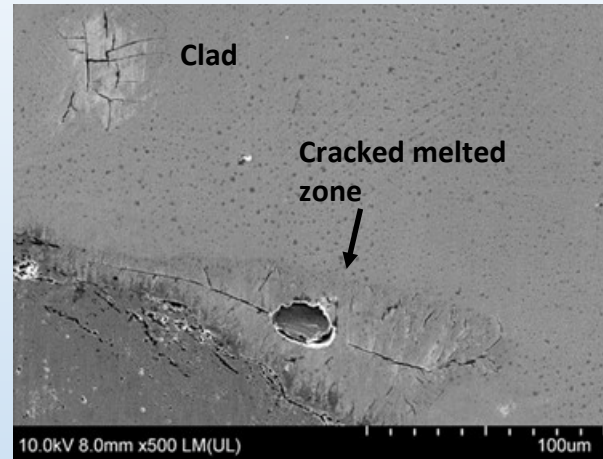
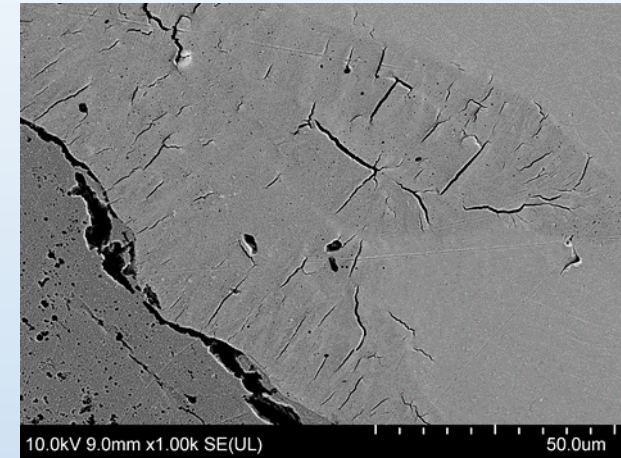
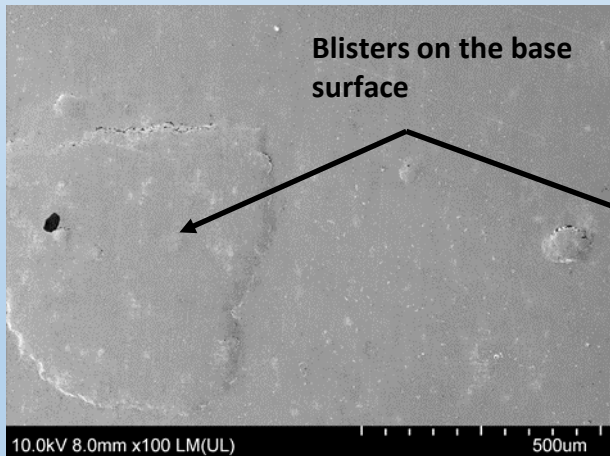
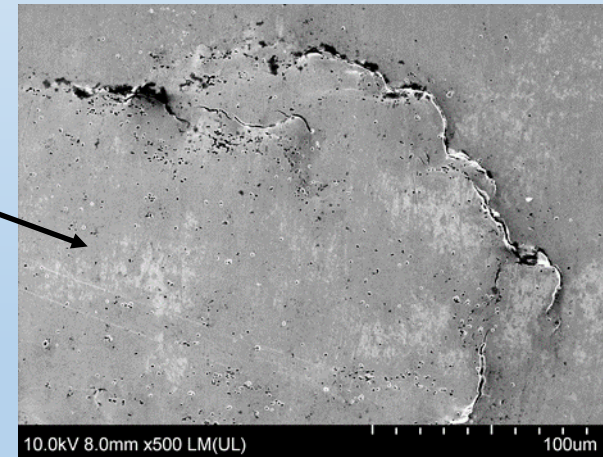
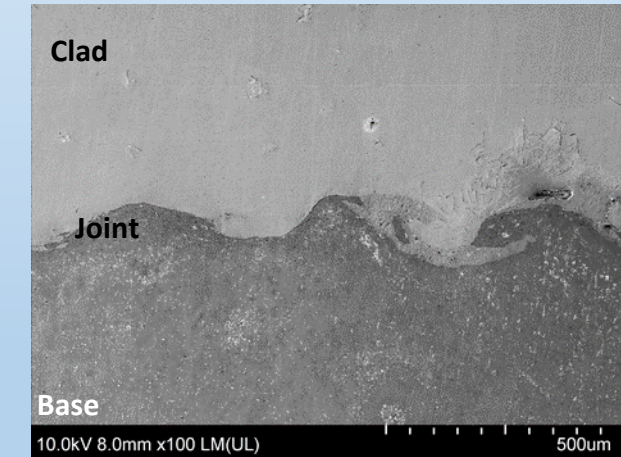
Sample 1.1 Base material: **P355NH**; Plate material: Inconel **C-276**. after hydrogen charging. Visible of cracked melted zones. Area of clad material (up to 500 μ m from the joint) remains unchanged

- ❑ **Obtained joints have wavy character what is typical fo explosive welding process.**
- ❑ **Hydrogen causes significant changes in microstructure in the flyer layer (surface microcracks and blisters) and base layer (blisters) of the investigated clad plates.**
- ❑ **In the process of explosive welding a strong deformation occurs adjacent to the joint. It is evidenced by the increased hardness of the metal near the joint and changing the shape of equiaxed grains in the elongated and refining of grains.**
- ❑ **Investigations of the local melted zones, formed at the interface of the explosively bonded low alloy and austenitic stainlss steels, have shown that the zones have an intermediate chemical composition, and exhibit in some case higher resistance to hydrogen corrosion than the bonded materials.**

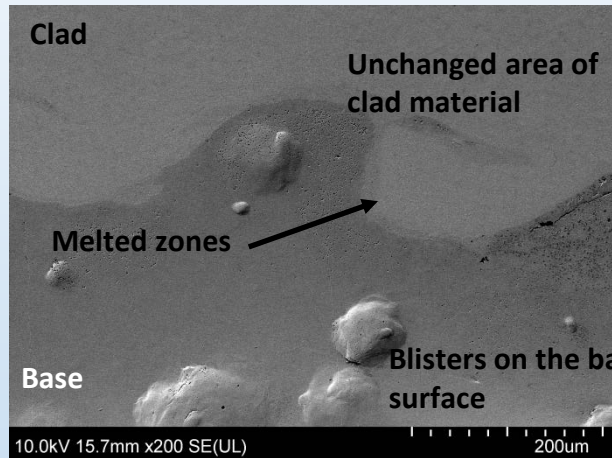
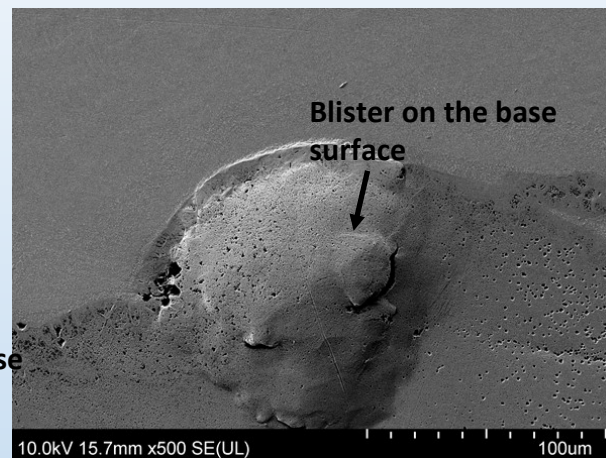
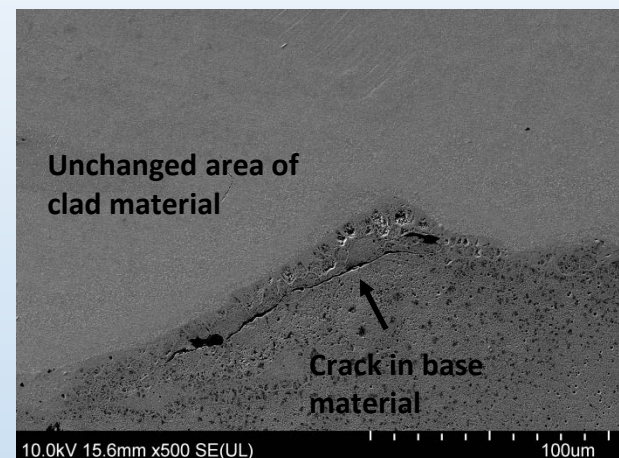
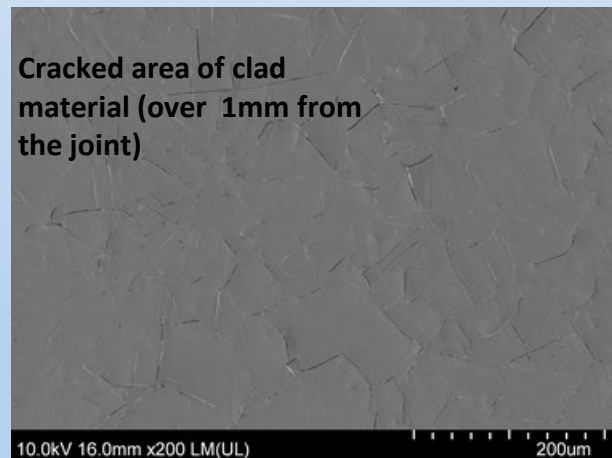
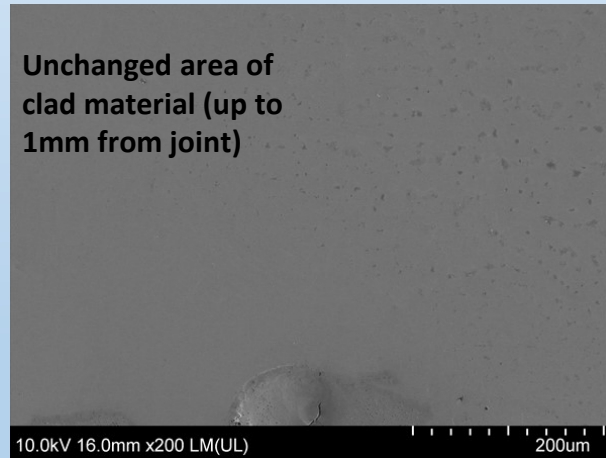
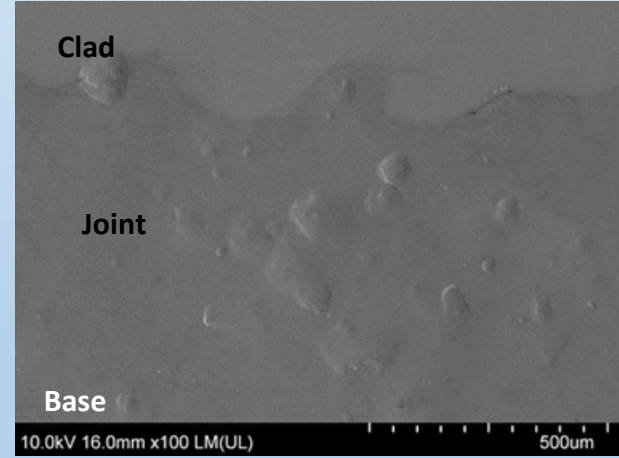
Sample 1.2 (annealed 610°C) Base material: **P355NH**; Plate material: Inconel **C-276** after hydrogen charging. Area of clad material (up to 1000µm from the joint) remains unchanged

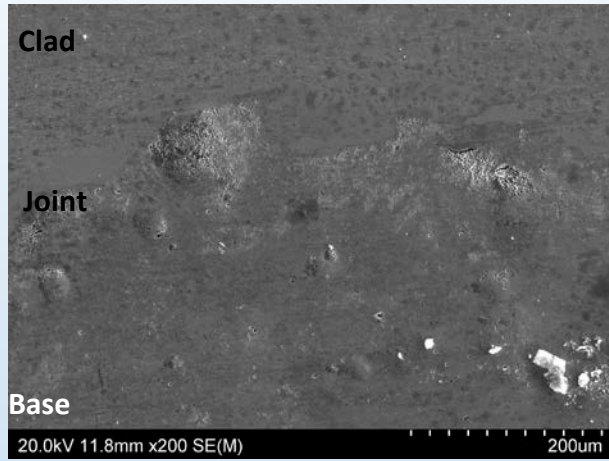
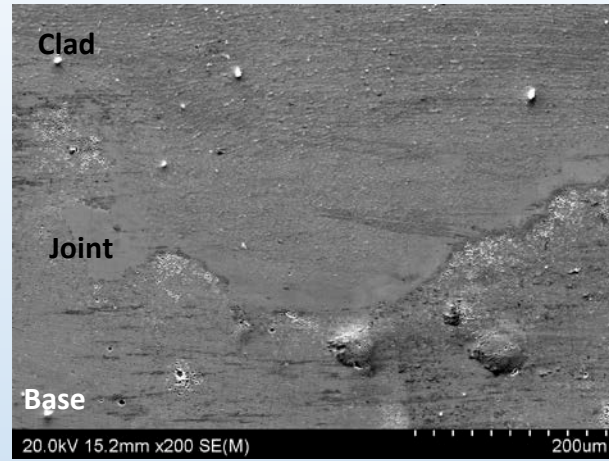
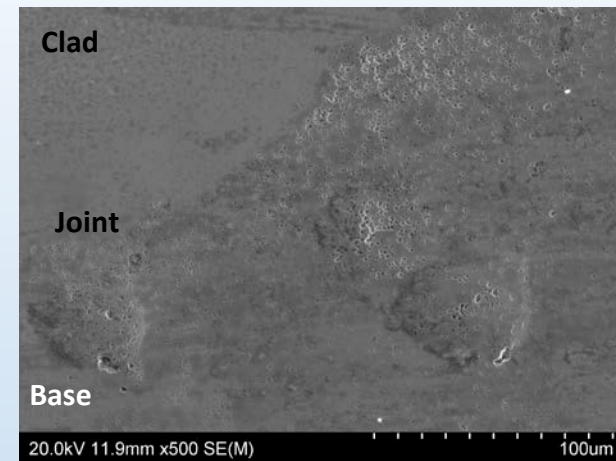
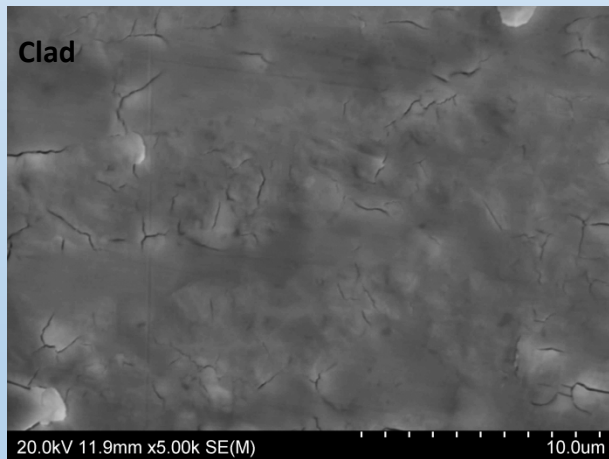
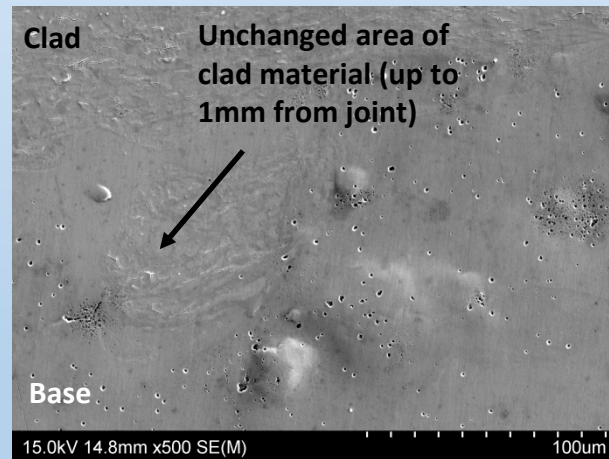
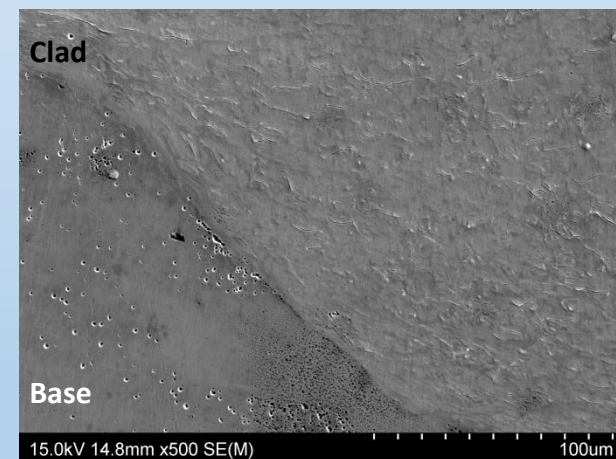
Sample 2.1, Base material: P355NH; Plate material: SAF 2507, austenitic-ferritic stainless steel.

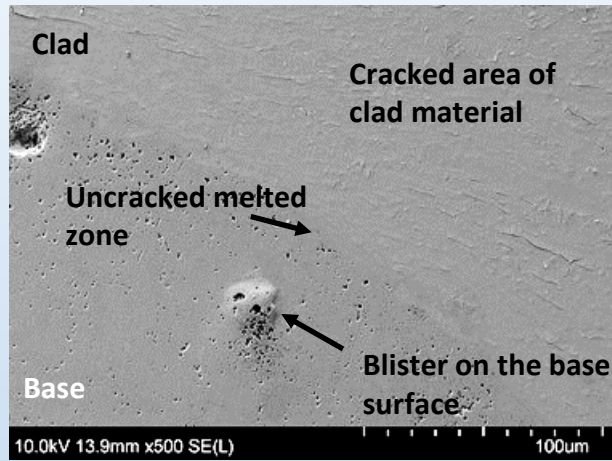
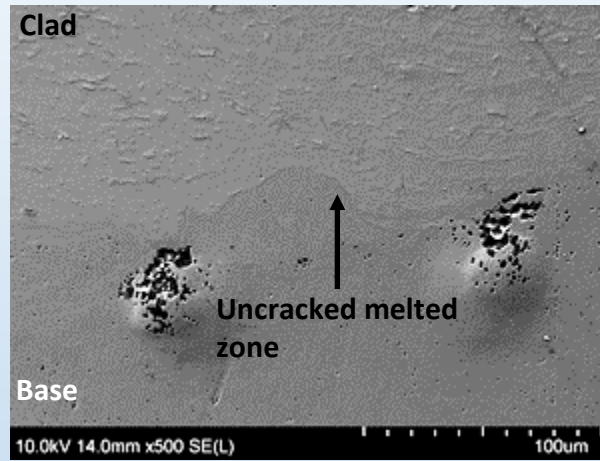
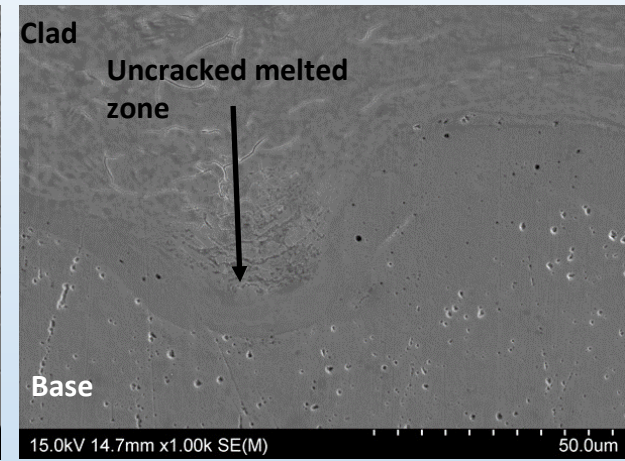
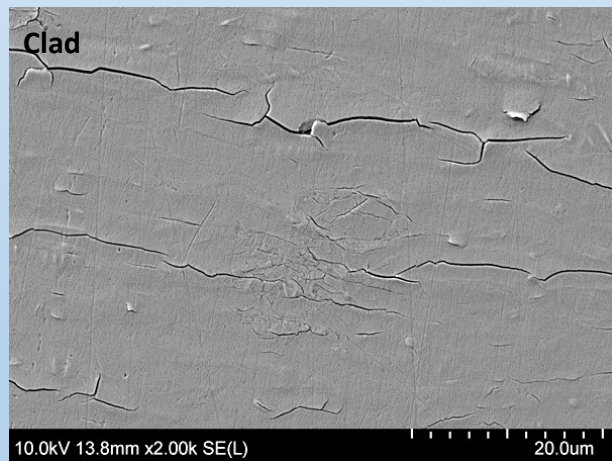
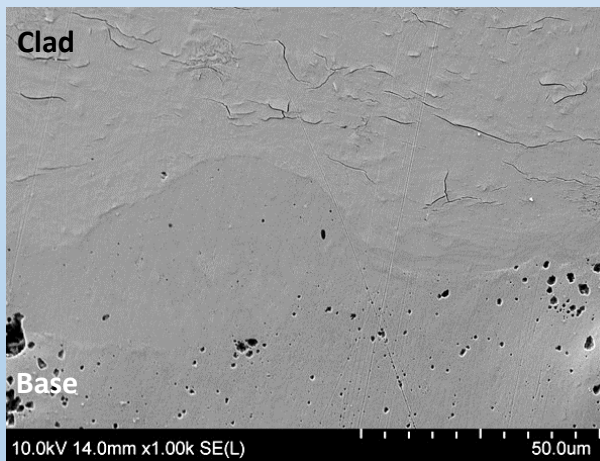
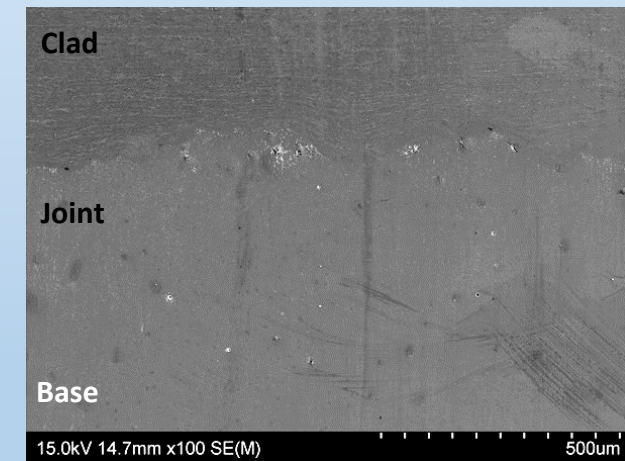
Sample 2.2 (annealed 610⁰C), Base material: **P355NH**; Plate material: **SAF 2507**, austenitic-ferritic stainless steel
